ROCKETDYNE

R-5316

FINAL REPORT, DEVELOPMENT OF DOWNRATED
ATLAS YLR101-NA-15 VERNIER ENGINE

Contract AF04(695)-306

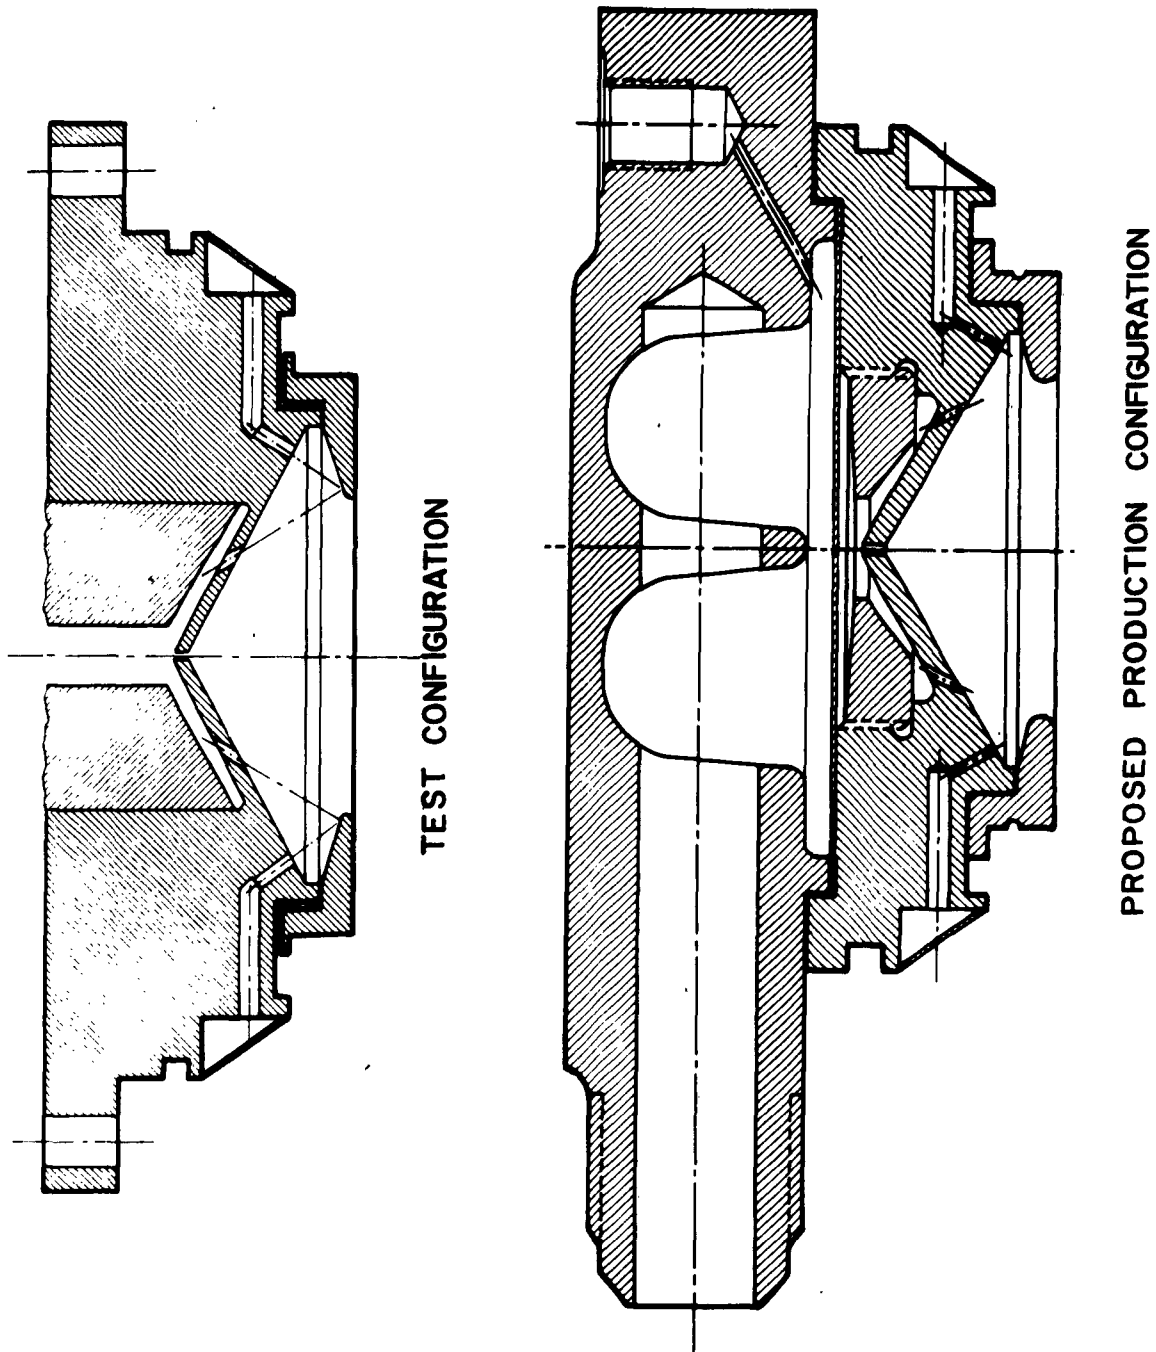
Figure 23. Vernier Splash-Plate Injector

The splash-plate injector (Fig. 23) was designed to force liquid mixing and particle breakup by allowing the streams of oxidizer and fuel to simultaneously impinge at the surface of the splash plate. Advantages of this design were: (1) fabrication simplicity, (2) high performance, and (3) previous history of no thrust chamber erosion.

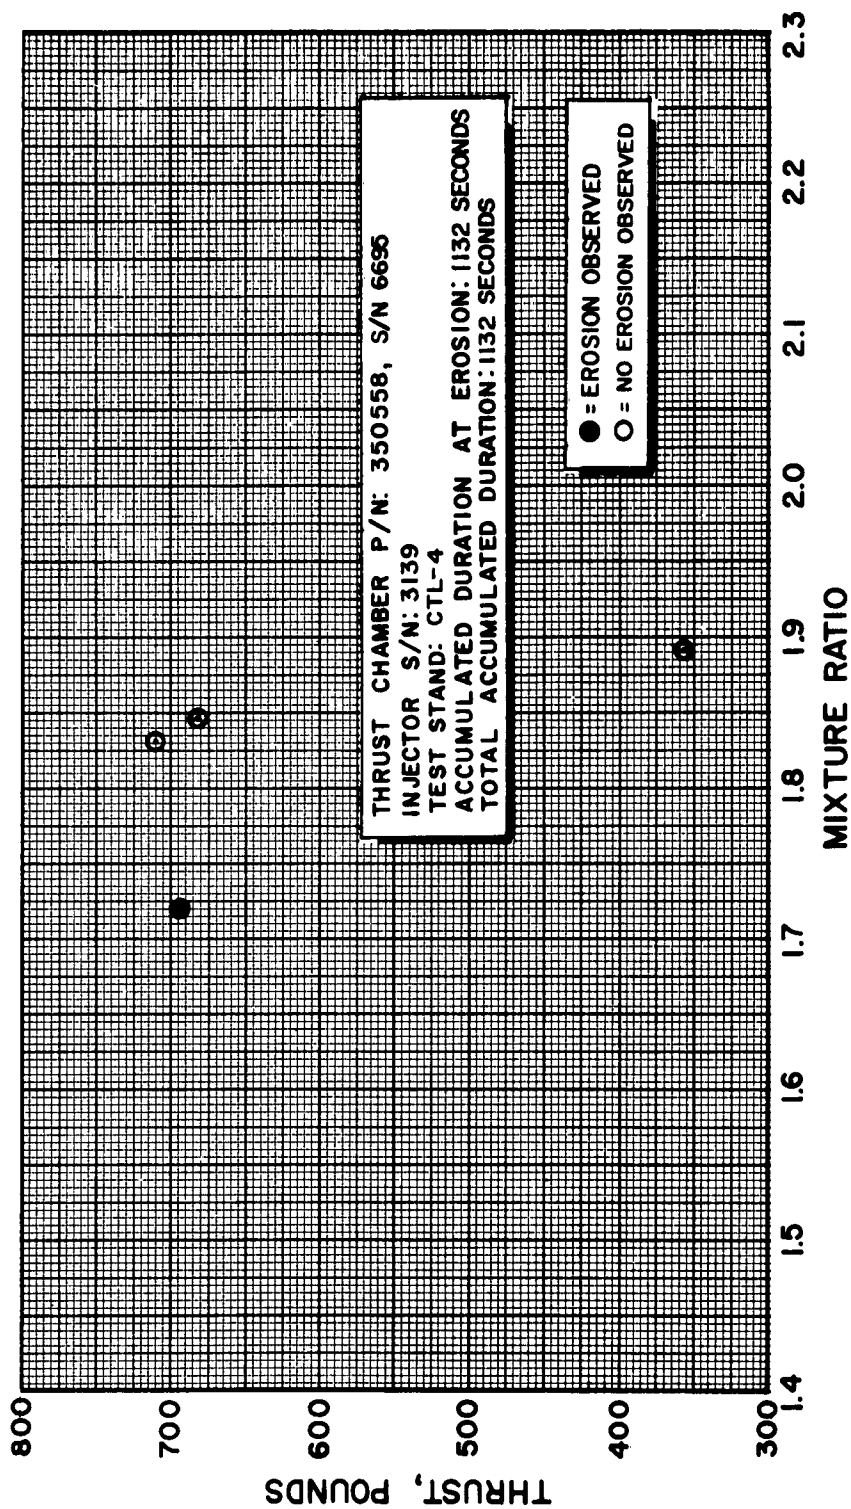
Figure 27. Operating Regime of Injector P/N E0 119924
Tested with Thrust Chamber S/N 6695

Testing of the P/N EO 119924 injector was terminated after the fourth duration test because of heavy thrust chamber erosion (Fig. 26). Because the oxidizer tank pressure was increased to reach the planned mixture ratio, the cause of erosion has not been definitely established. However, calculation of transition mixture ratio showed no cause of thrust chamber erosion resulting from this shift in tank pressure. The thrust chamber inner-wall erosion was located 3 inches upstream of the throat and was through the wall. Minor nickel and parent metal erosion was evident at several other points. No evidence of erosion was detectable during the test or during close examination of the data. No further testing was attempted on this unit. The operating regime for the P/N EO 119924 injector is shown in Fig. 27.

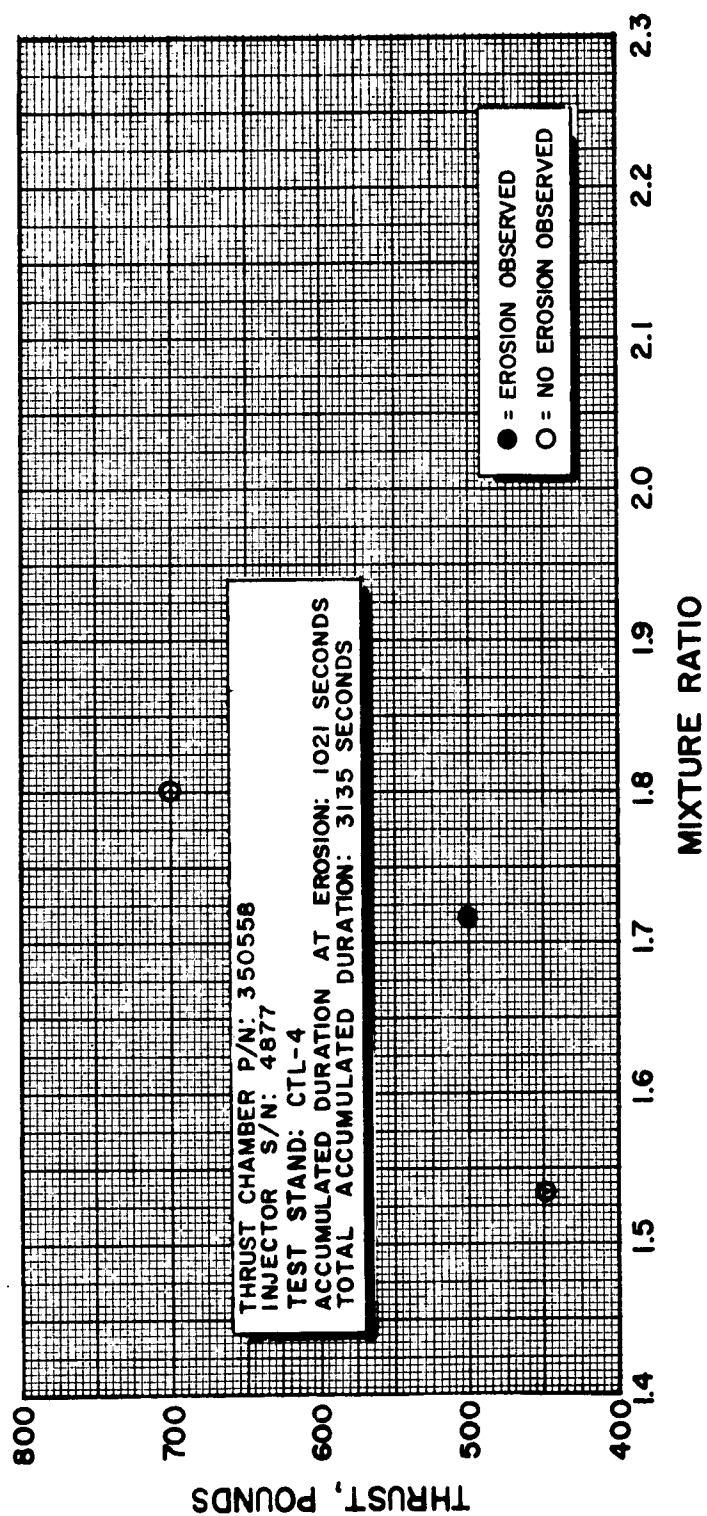
Figure 28. Operating Regime of Injector P/N E0 123830
Tested With Thrust Chamber S/N 6326

Ten duration tests were completed on the P/N EO 123830 injector. The first test was terminated early because of the erratic parameters, and the 2-inch facility line was replaced by a 1-inch line to eliminate any problem with gaseous oxygen. The testing was continued with only a slight shift in the performance parameters. Minor thrust chamber erosion was evident after 700 seconds, but testing was continued after concluding that the erosion had been caused by a plugged orifice. No further erosion occurred during subsequent tests. The second P/N EO 123830 unit was not tested because of heavy streaking noted when the first chamber was sectioned and inspected following testing (Fig. 26). The operating regime of the P/N EO 123830 injector until the time of erosion is shown in Fig. 28.

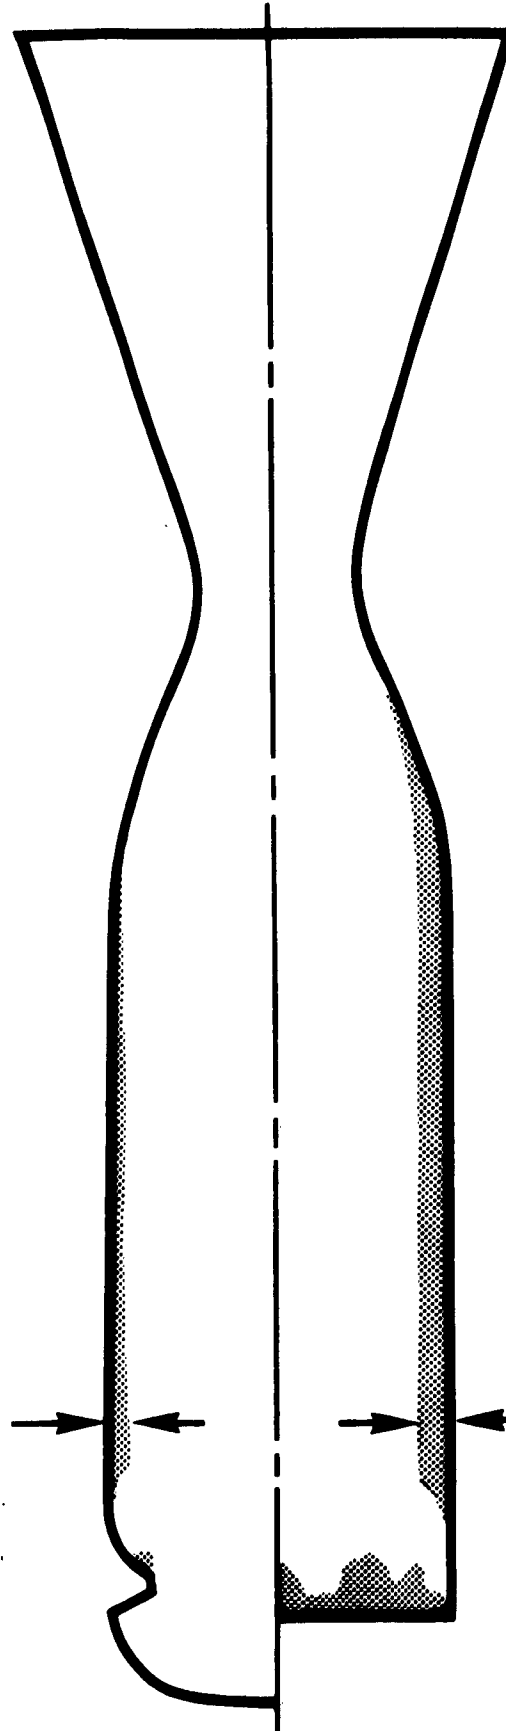
Carbon Buildup. Carbon buildup (Fig. 36) was found in the thrust chamber and on the injector face throughout the flat-face injector testing. Hard carbon up to 1/2-inch thick formed on the injector face upstream of the impinging propellant streams, and some pieces of carbon found in the test area showed the orifice pattern. The first three tests on each injector generally exhibited the heaviest carbon buildup, but random buildup was also evident during later tests. Soft carbon on the wall of the thrust chamber in line with each injector fuel orifice spoke gradually built up to a maximum thickness of 0.125 inch after several tests. Carbon buildup in the thrust chamber throat was not evident during the series.

A lesser degree of carbon buildup (Fig. 36) also was visible in the thrust chamber following splash-plate injector tests. Hard carbon on the wall at the injector end reached a 0.040-inch thickness, but decreased to zero thickness approximately 4 inches downstream. No carbon buildup was visible on the splash-plate injector face or in the thrust chamber throat, although it was assumed to have been in the throat as a result of the shifting performance and carbon particles found in the test area.

THRUST CHAMBER USING FLAT - FACE INJECTOR

0.125 - INCH MAXIMUM

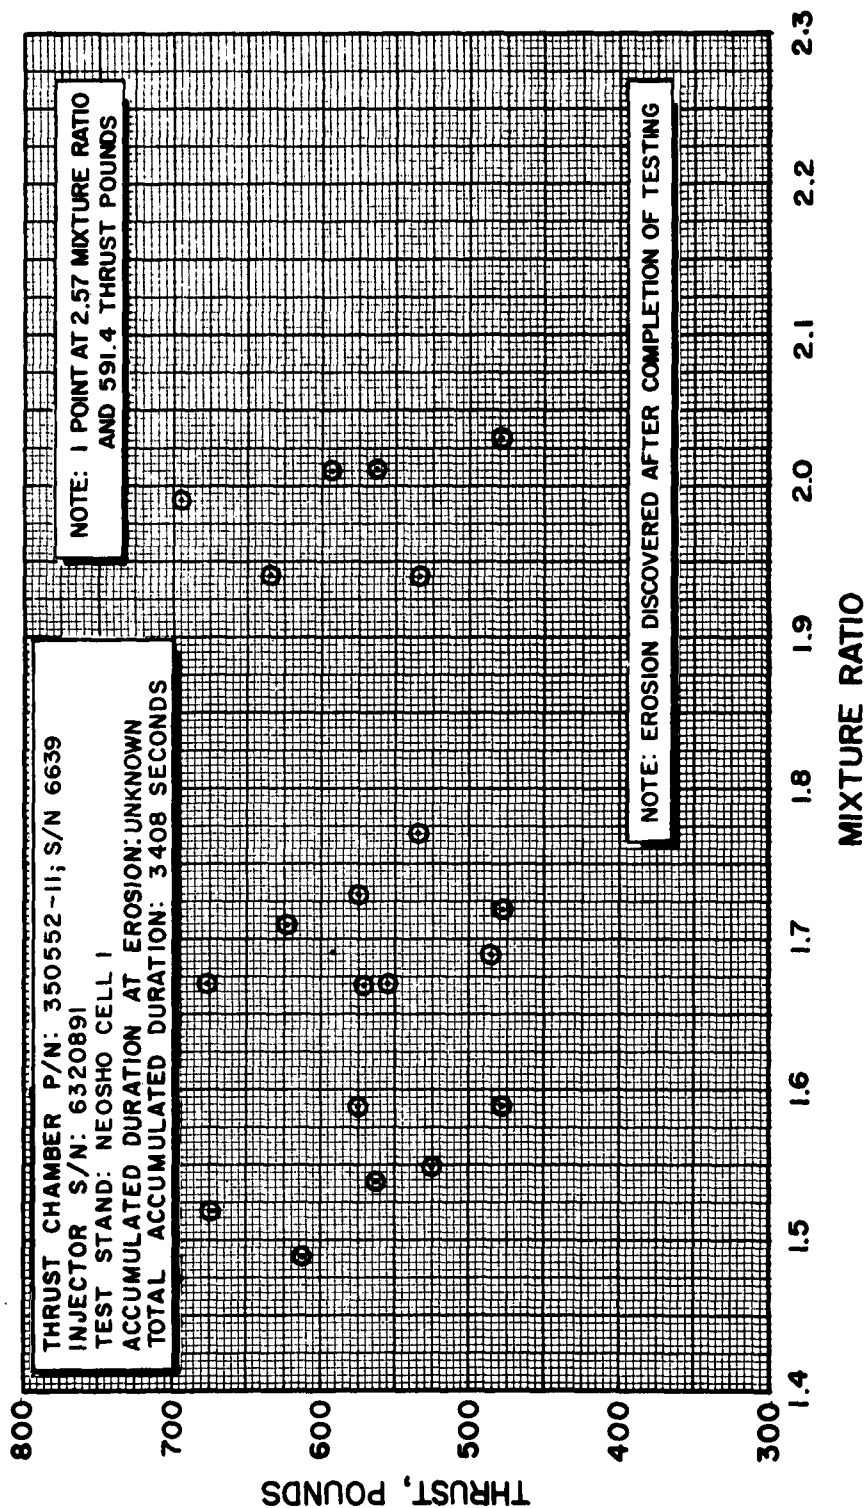
Figure 38. Operating Regime of Injector P/N E0 123829
Tested With Engine S/N 3401.

The first P/N E0 123829 injector unit completed the test series with no recorded thrust chamber erosion (Fig. 38) but erosion was found in the combustion zone during disassembly. At the time of this discovery, seven tests had already been completed on the second test unit. This unit was immediately disassembled, carbon was removed from the combustion zone, and erosion was noted in the combustion zone. The operating regime of this unit until the time that thrust chamber erosion was noted is shown in Fig. 39. As a result of this incident, the procedure for determining erosion was revised to encompass disassembly of the thrust chamber/injector combination and removal of combustion zone carbon.

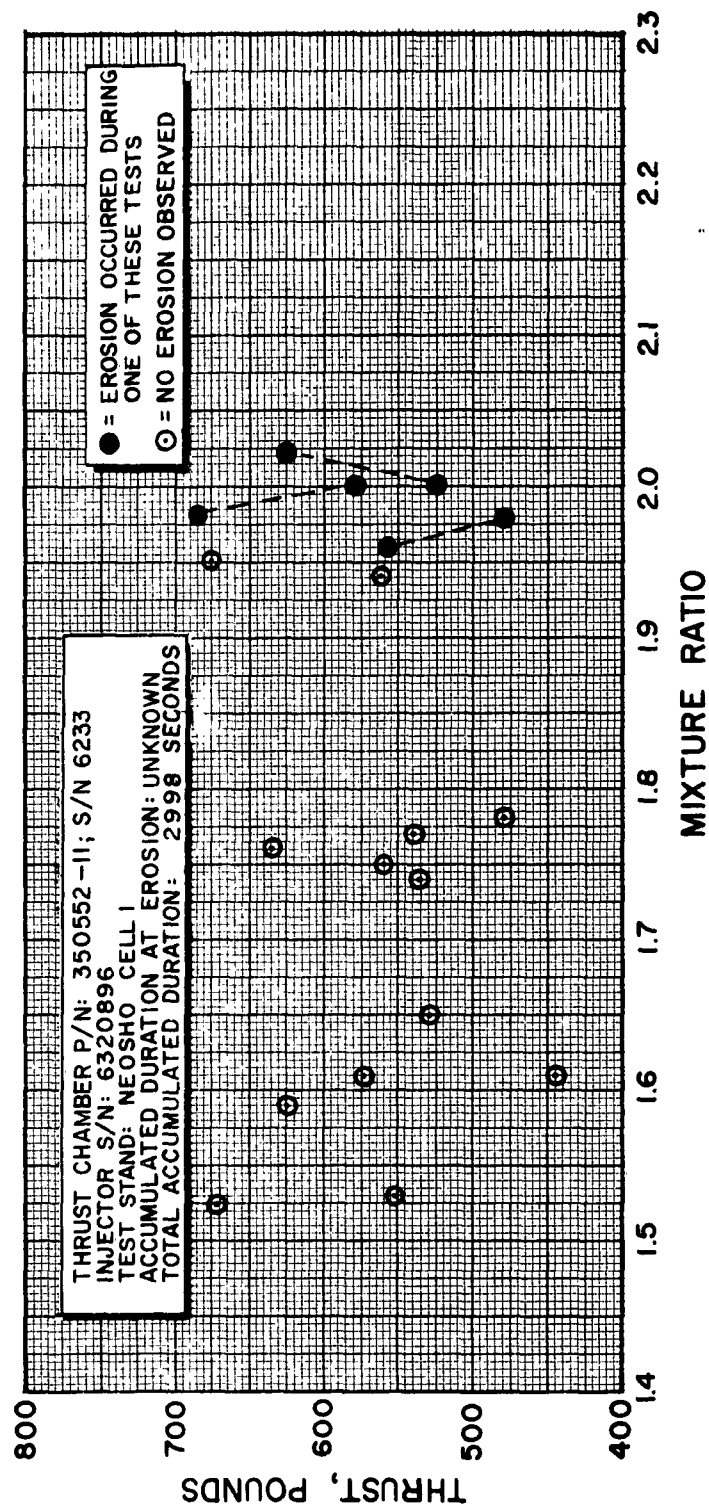
Figure 40. Operating Regime of Injector P/N E0 123829
Tested With Engine S/N 3401-2.

The third unit tested operated in the regime indicated in Fig. 40 until the time of initial erosion.

The occurrence of erosion on the first two units, coupled with the damage on the third unit in the high mixture ratio operating range, resulted in the splash-plate unit being used on the next vernier engine assembly. The operating regime of this unit until the time of initial thrust chamber erosion is shown in Fig. 41. In addition to the unsatisfactory erosion pattern exhibited by this injector, large thrust variations were experienced as the result of heavy carbon formations at the thrust chamber throat. Testing of the splash-plate unit was discontinued.

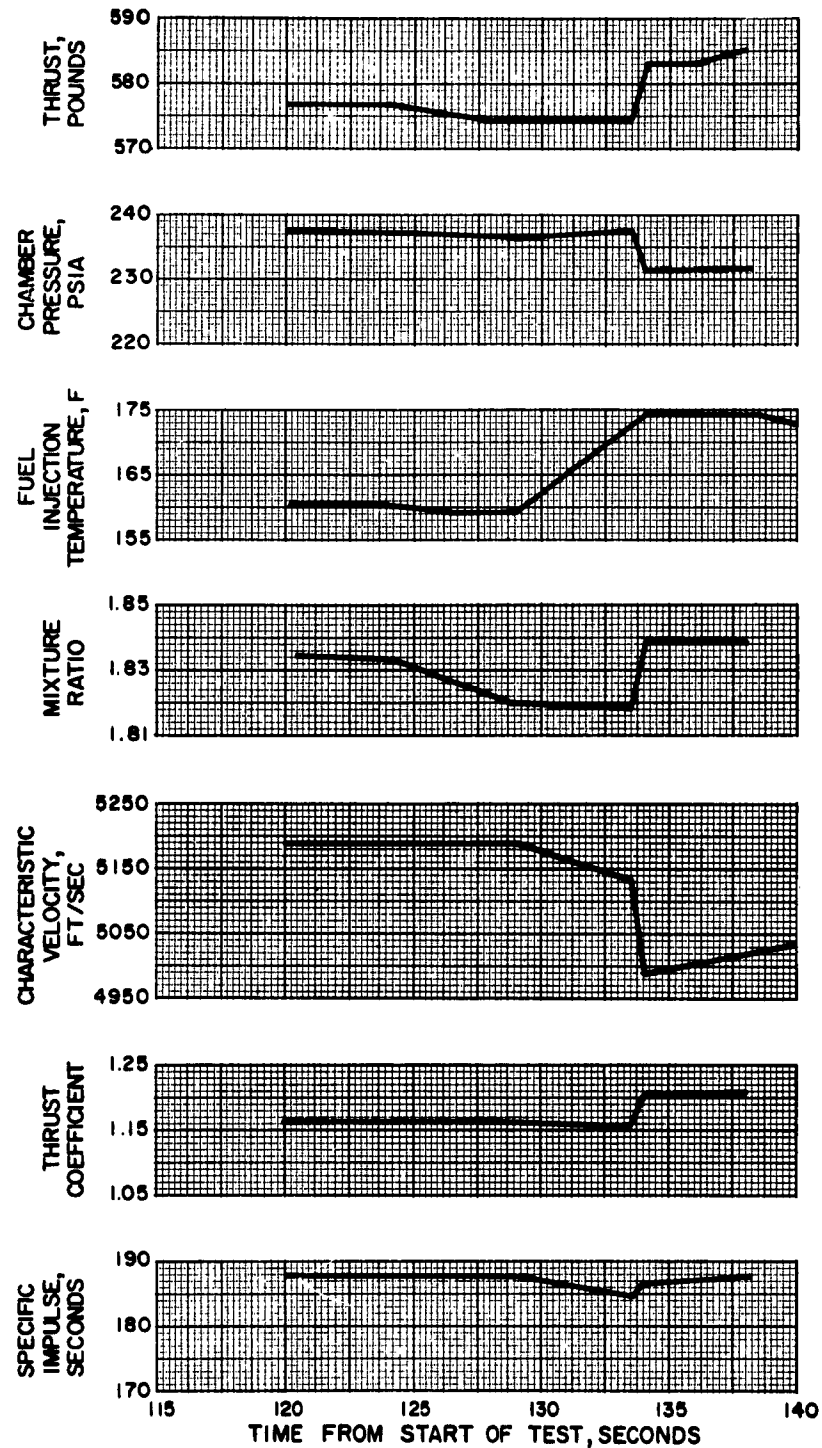
Figure 53. Engine S/N 3402-2 Performance Shift During Run No. 8019
Using Injector P/N E0 123829, S/N 6320895

3. Performance shifts comparable to those obtained at the 1000-pound thrust level with the P/N 350604 injector occurred sporadically throughout the test series on the P/N E0 123829 injector (Fig. 53). The cause of these shifts is not as easily traced as the previous two. Injector hole patterns found in carbon particles after the tests showed that the carbon had built up on the face of the injector. During posttest inspections, carbon particles also were found adhering to the face of the injector. Removal of one injector revealed two triangular-shaped pieces of carbon at the junction of the injector and thrust chamber. These carbon pieces

showed the location of the outer fuel holes. The pieces were measured and are represented in Fig. 54. It is believed that carbon buildup and breaking away across the face of the injector may have caused changes in the impingement pattern which in turn produced the performance shifts.

The fuel injection temperature randomly varied during all tests, with an amplitude of as much as 15 F. This variation in temperature could not be correlated with carbon buildup and breaking away except as noted in Fig. 51 and 53, but it does provide an indication that the temperature at the thrust chamber inner wall varied during the tests. Similar fuel injection temperature fluctuations previously were noted with the P/N 350604 injector during Phase I testing.

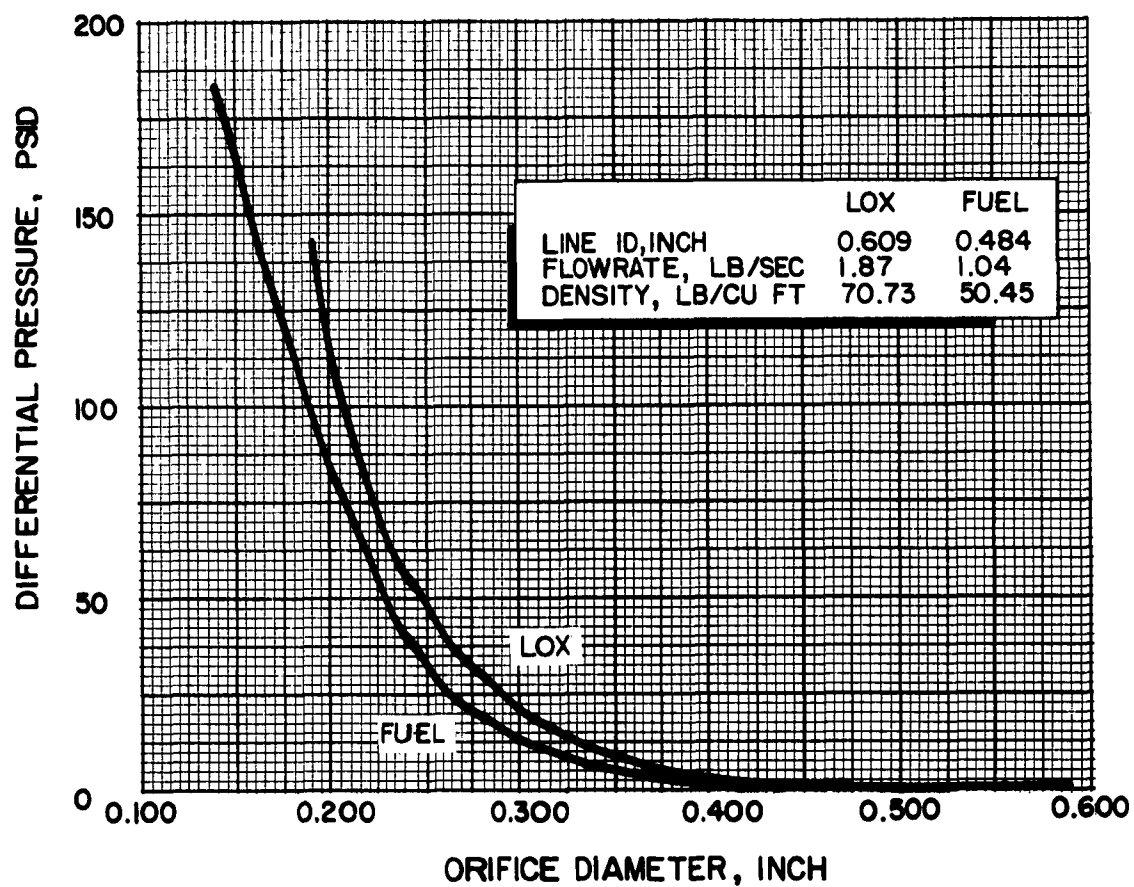
Figure A-2. Differential Pressure Through GD/A Orifices Reversed in Holders

The orifices used had a 45-degree countersink on the downstream side. This resulted in greater efficiency. The orificing could be reversed at the time of installation, so data also were obtained with the orifices installed incorrectly (countersink on the upstream side of the orifice). Figures A-2, A-3, and A-4 show the results of improper orifice installation. Because of the extreme loss in orifice efficiency, it is recommended that these orifices be designed so that improper orifice installation is impossible.
